**PHASE I ENVIRONMENTAL SITE ASSESSMENT**  
**2510 SOUTH CEDAR STREET**  
**CITY OF LANSING, MICHIGAN**

**THE LANSING**  
**BROWNFIELD REDEVELOPMENT AUTHORITY**  
**LANSING, MICHIGAN**

**AKT PEERLESS PROJECT NO. 3268S-2-17**  
**JULY 27, 2001**

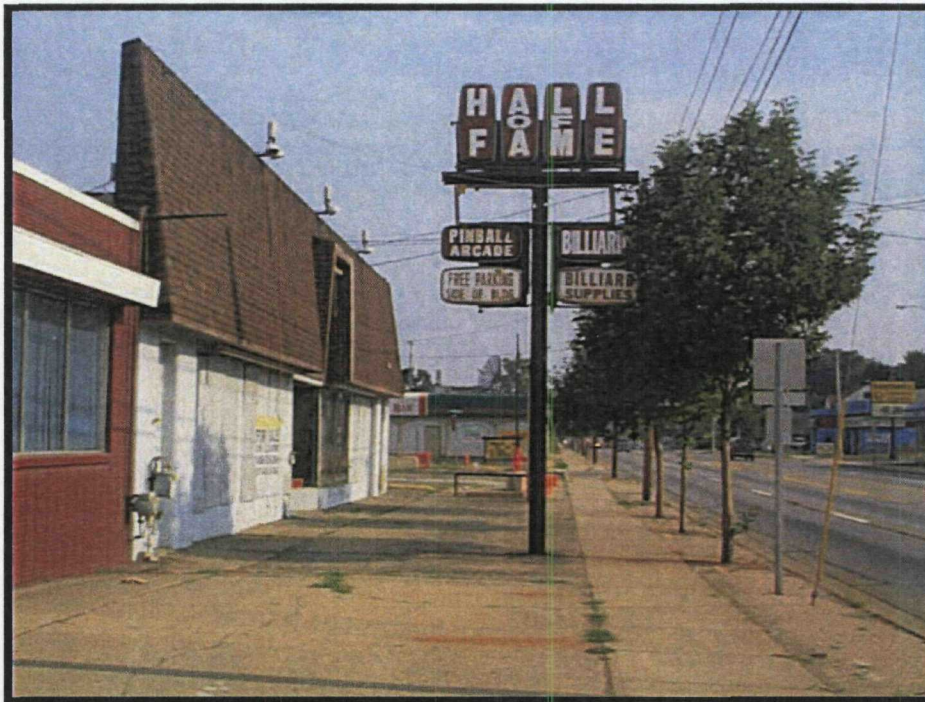
1.) VIEW OF THE EAST SIDE OF THE SUBJECT PROPERTY FROM THE SOUTHEAST

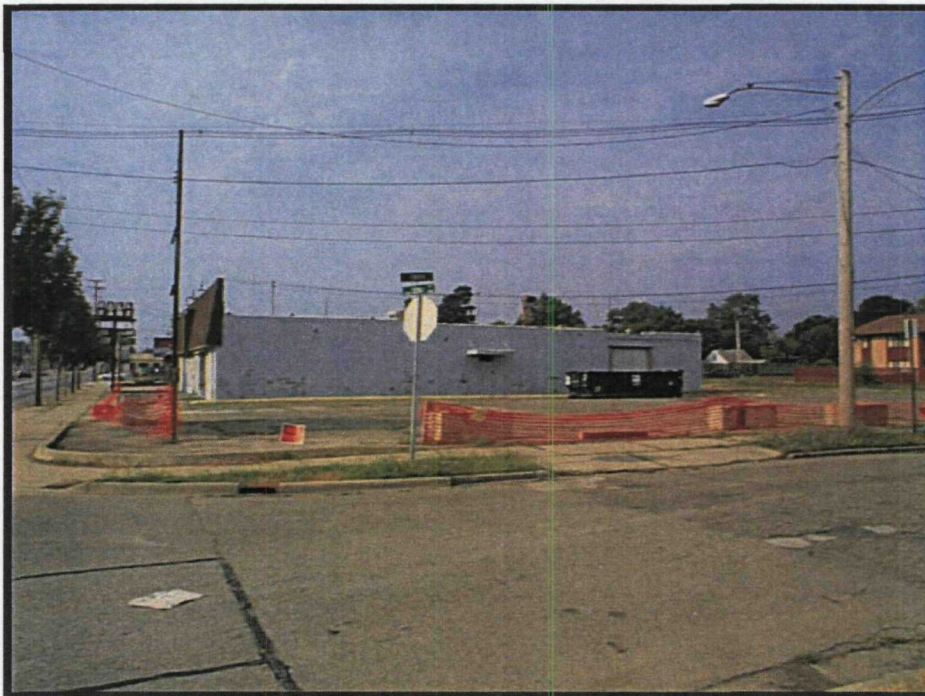
2.) VIEW OF THE SUBJECT PROPERTY FROM THE NORTHEAST

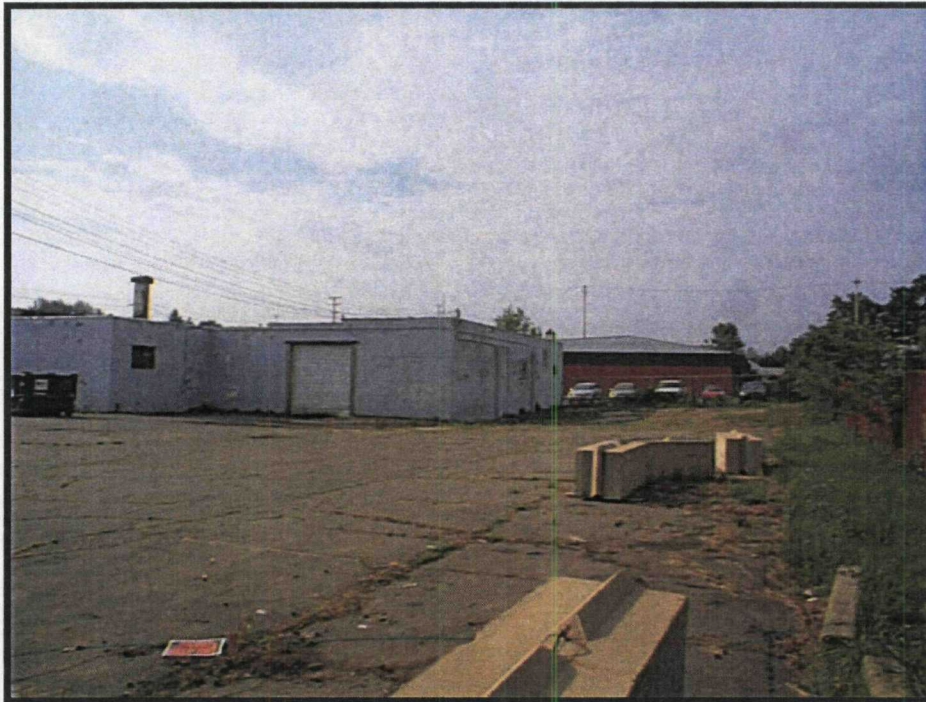
3.) VIEW OF THE WEST SIDE OF THE SUBJECT PROPERTY FROM THE NORTHWEST

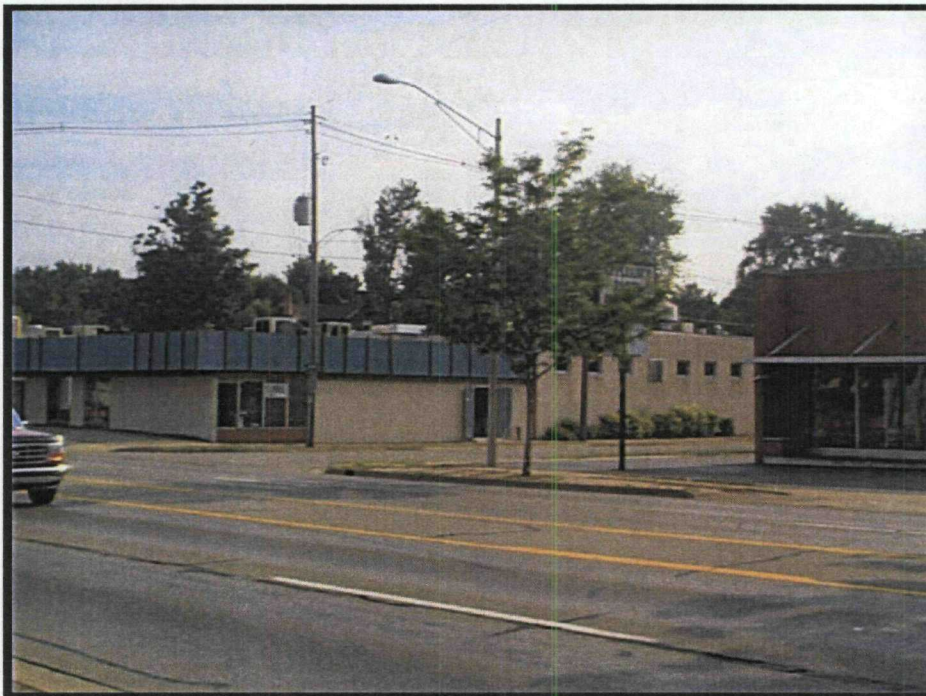
Several properties, located east of the subject property across South Cedar Street, likely used storage tanks, petroleum products, and/or hazardous chemicals during normal business operations. Due to lack of information regarding these adjoining properties and the current use of one property as a dry cleaning operation (Baryames Dry Cleaners), these properties represent the potential for a past release, an existing release, or a material threat of a release of hazardous substances or petroleum products to the subject property and are a REC in connection with the subject property.

4.) VIEW OF THE ADJOINING PROPERTIES (BARYAMES DRY CLEANER/FORMER FILLING STATION, ON THE NORTHEAST CORNER AND FORMER DRY CLEANING OPERATION, ON THE SOUTHEAST CORNERS OF LINCOLN AND S. CEDAR)

1. As discussed in Section 3.3.6, several adjoining properties, located east of the subject property across South Cedar Street, likely used storage tanks, petroleum products, and/or hazardous chemicals during normal business operations. Due to lack of information regarding these adjoining properties and the current use of one property as a dry cleaning operation (Baryames Dry Cleaners), these properties represent the potential for a past release, an existing release, or a material threat of a release of hazardous substances or petroleum products to the subject property.

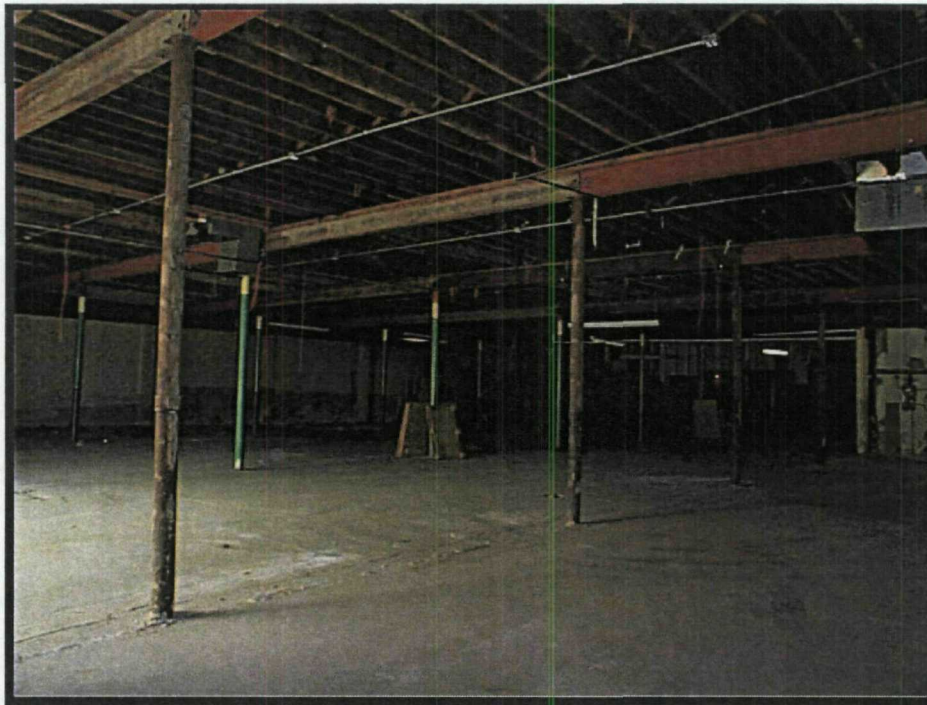
5.) VIEW OF BUILDING INTERIOR FACING SOUTHWEST

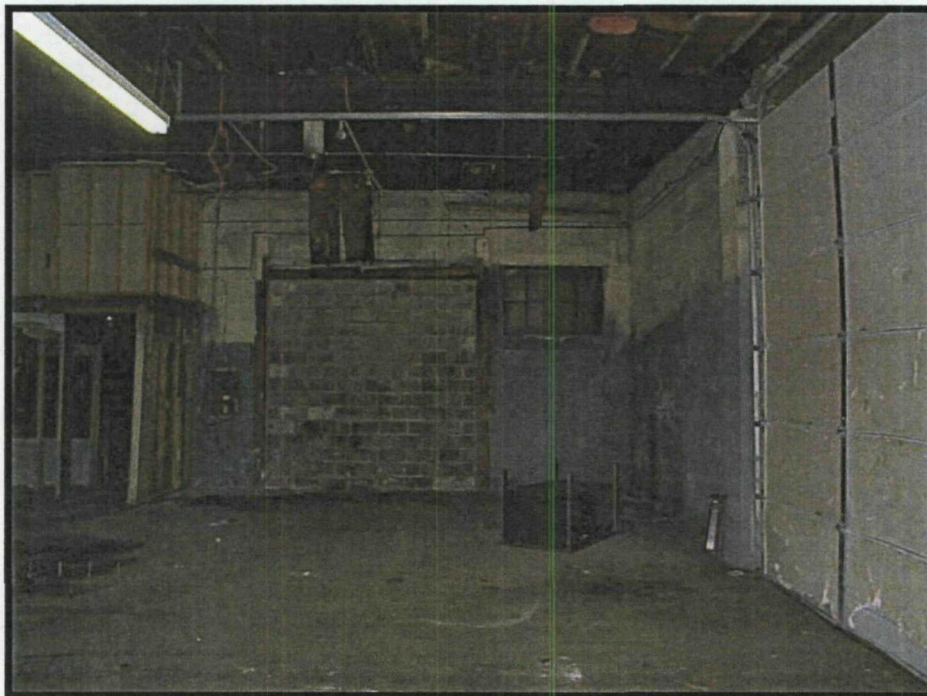
AKT Peerless observed two floor drains in the northwest portion of the subject property building. Miscellaneous staining was observed in the area surrounding these floor drains. Due to the unknown origin of this staining, it is AKT Peerless' opinion this area represents the potential for

past release of petroleum products and/or hazardous substances to the subject property's subsurface and is a REC in connection with the subject property.

AKT Peerless also observed a floor pit in the northwest portion of the subject property building. This floor pit was approximately two feet deep and had a pipe protruding from the western side of the pit just below ground level. The floor of the pit was covered with dirt and gravel. AKT Peerless was unable to determine, during the site walkthrough, if this dirt and gravel floor was contained by a cement bottom. Due to the unknown use of this pit, it is AKT Peerless' opinion this area represents the potential for past release of petroleum products and/or hazardous substances to the subject property's subsurface and is a REC in connection with the subject property.

6.) VIEW OF BUILDING INTERIOR FACING WEST, DEPICTING AREA OF FLOOR DRAINS AND FLOOR PIT

AKT Peerless recommends a subsurface investigation be conducted at the subject property to evaluate subsurface conditions and assess the potential presence of an UST.

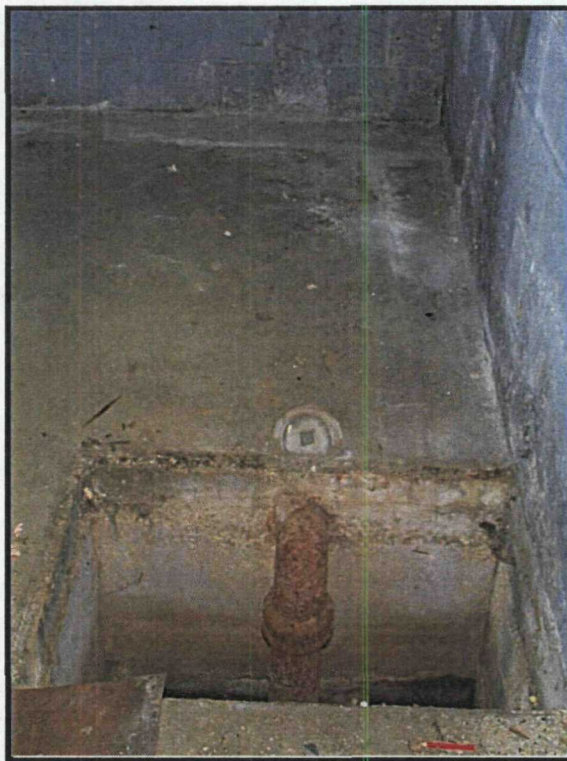
9.) VIEW OF FLOOR PIT, DRAIN PIPE, AND CLEANOUTS FACING WEST

4. As discussed in Section 4.8, AKT Peerless observed a floor pit in the northwest portion of the subject property building. Due to the unknown use of this pit, it is AKT Peerless' opinion this area represents the potential for past release of petroleum products and/or hazardous substances to the subject property's subsurface.

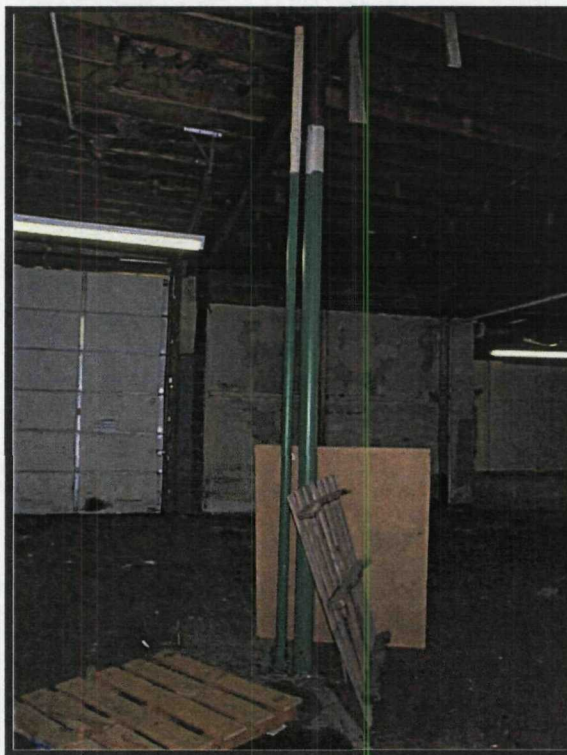
AKT Peerless noted the presence of a suspect vent pipe and fill pipe in the northwest portion of the subject building. The suspect vent pipe, located next to a metal support beam, followed the support beam from the floor and continued up into the ceiling. The suspect fill pipe, located next to the suspect vent pipe, protruded out of the floor and was capped by a metal thread cap. It is AKT Peerless' opinion these suspect pipes could potentially be connected to an out-of-service UST. A UST represents the potential for a past release, an existing release, or material threat of a release of hazardous substances and/or petroleum products to the subject property and is a REC in connection with the subject property.

10.) VIEW OF SUSPECT VENT PIPE AND SUSPECT FILL PIPE FACING NORTH

2. As discussed in Section 4.4, a suspect vent pipe and fill pipe were located near the northwest corner of the subject property's building. It is AKT Peerless' opinion these suspect pipes could potentially be connected to an out-of-service UST. A UST represents the potential for a past release, existing release, or material threat of a release of hazardous substances and/or petroleum products to the subject property.
